**No Further Accelerated Action
Justification
for
Polychlorinated Biphenyl (PCB)
Potential Areas of Concern
(PAC) Sites**

(as proposed in 1996 HRR)

Rock Flats Environmental Technology Site

April 15, 2004

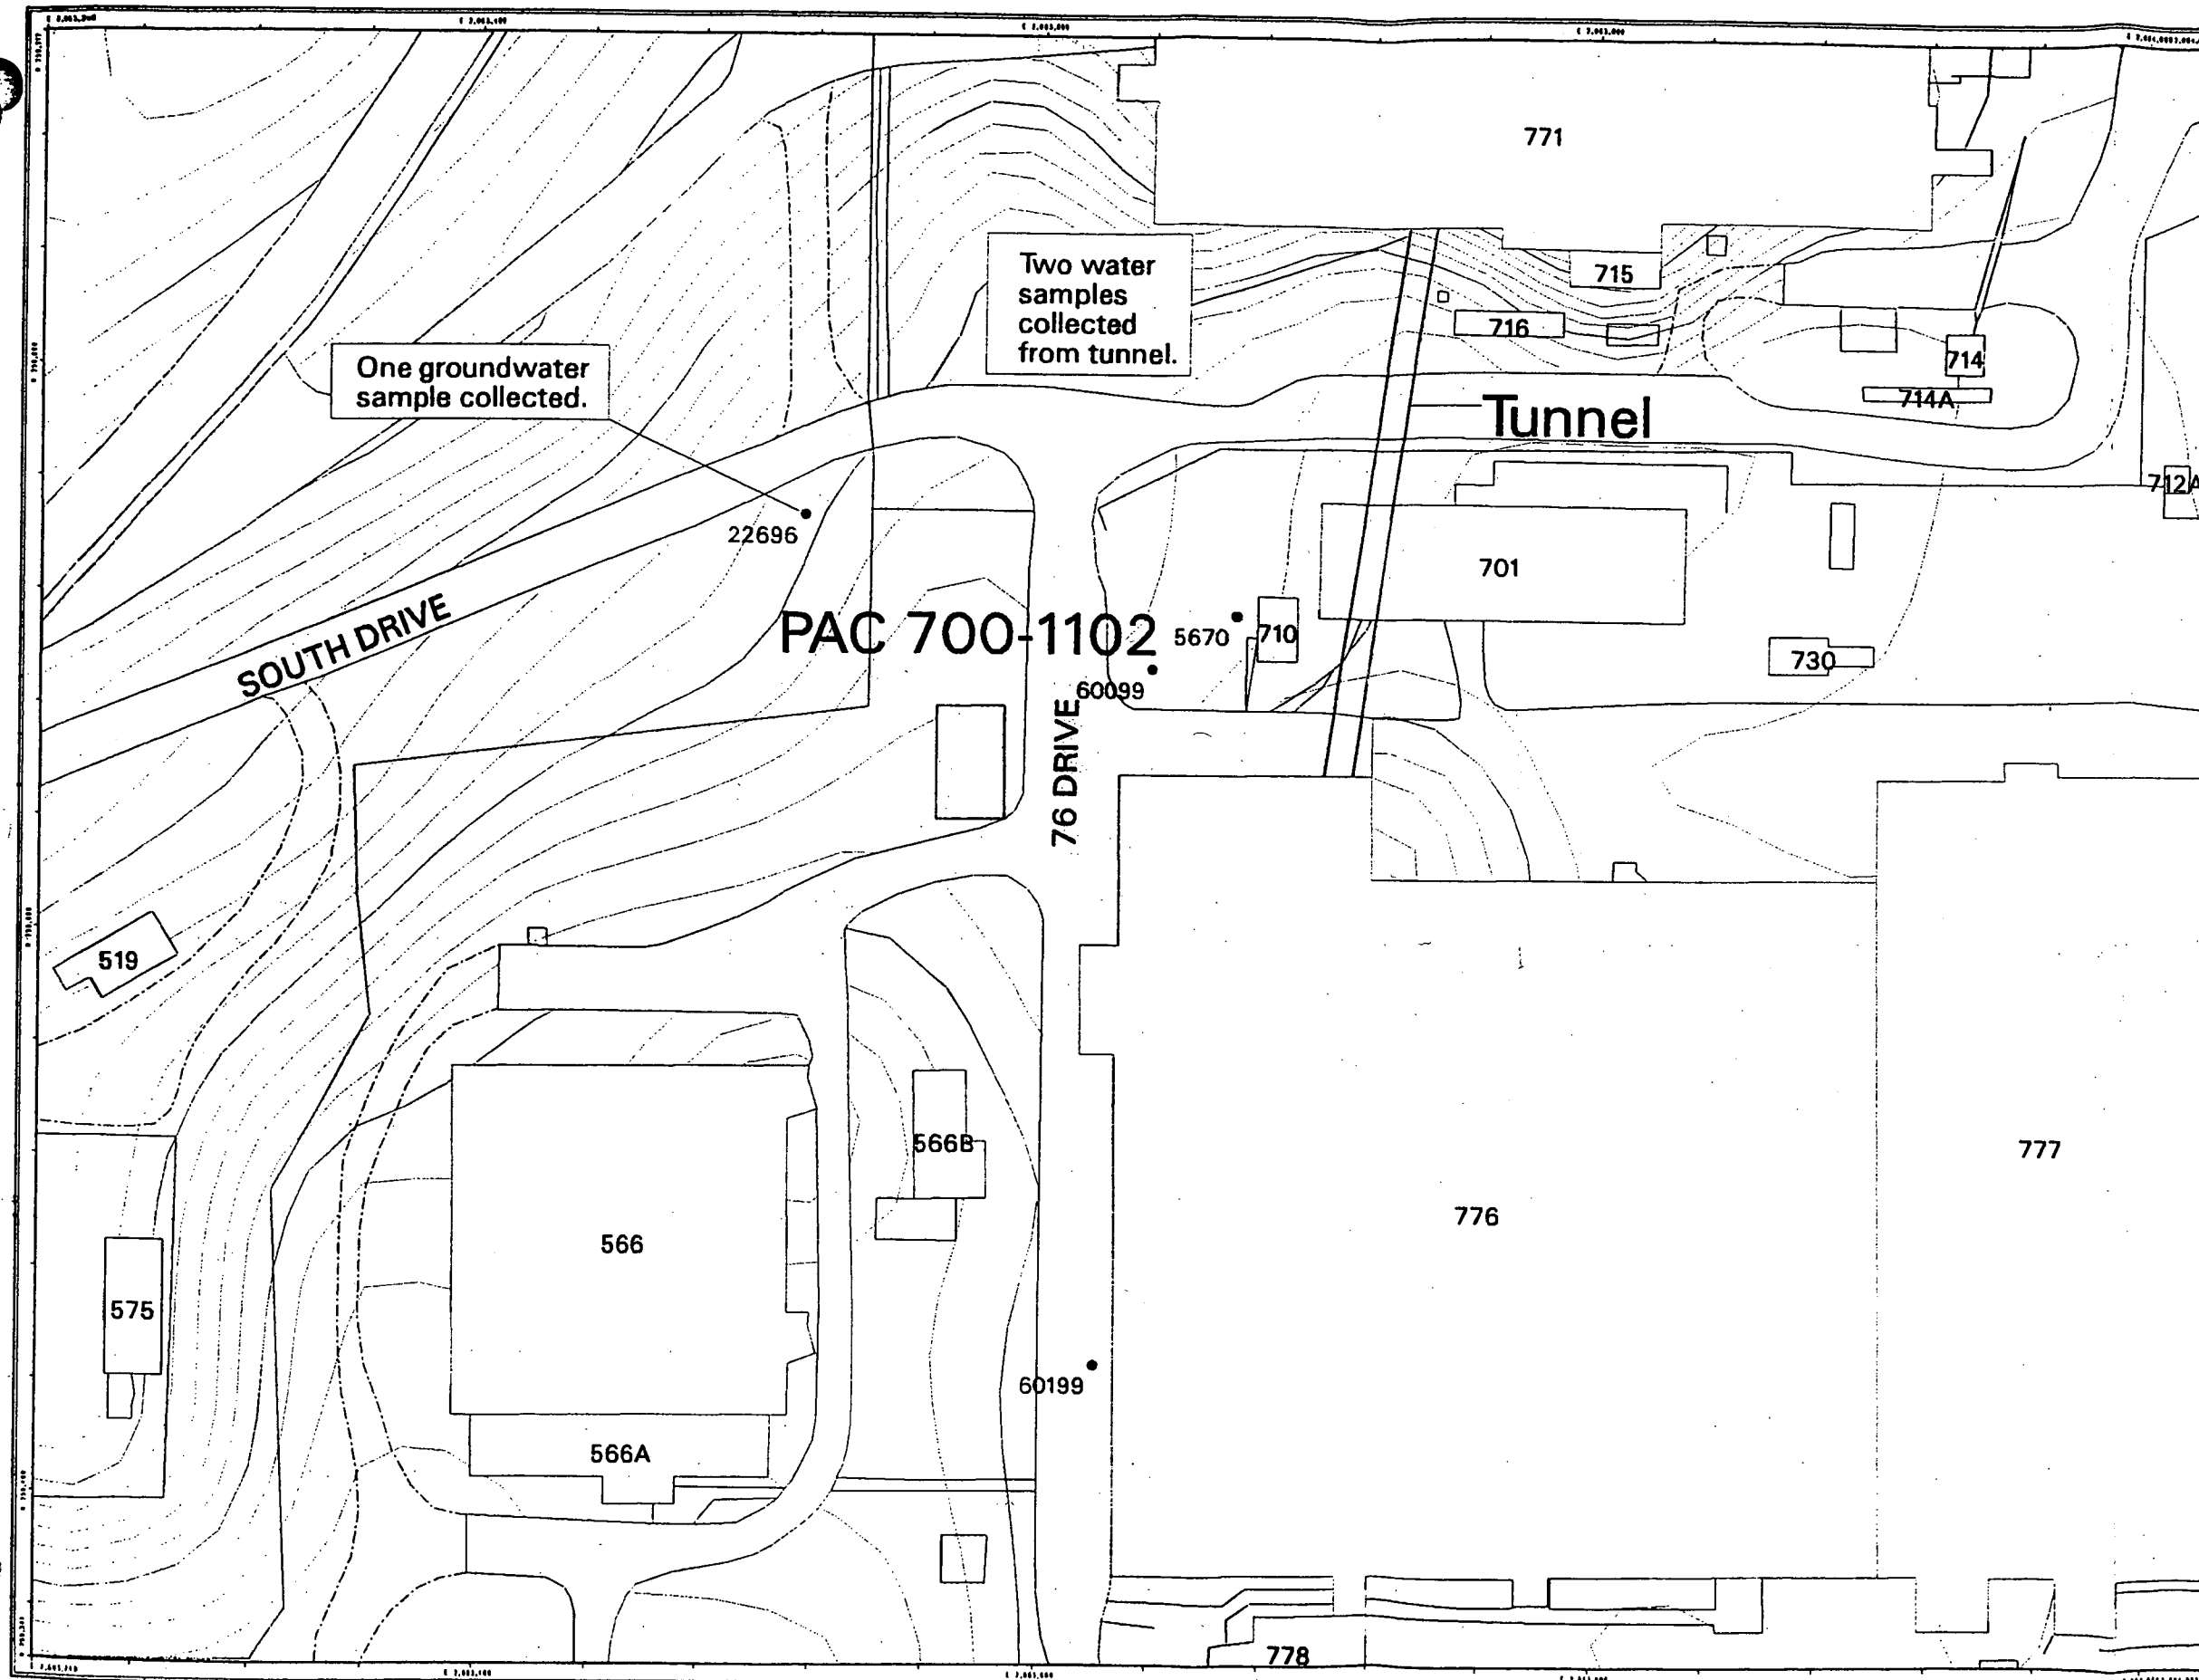
Figure 2.11
Historical Release Report
Potential Area of Concern
PAC 700-1102

Prior to January 1986, Transformer 776-4 was located approximately 100 feet west of the northwest corner of Building 776 (Figure 2.11). The transformer pad at this location was positioned on an incline with drainage toward an access road 15 feet to the east. In January 1986, a plant employee reported that a leak was observed from Transformer 776-4. In February 1986, the transformer was again reported to be leaking on the radiator, around the gauges, valves, and bushing compartment. There was an oily film on most of the surfaces of the transformer and on the transformer pad. In an August 1986 photograph, staining was visible on the concrete pad beneath the transformer. Further leaking was reported in August and September 1986. Samples collected in November 1986 of the concrete under the transformer drain valve and of soil at the south edge of the transformer pad were found to be contaminated with PCBs (DOE 1992). The transformer was moved to a new pad several feet to the north in 1987 (DOE 1996b).

In September 1976, the oil in Transformer 776-4 had a PCB concentration of approximately 5 percent (using a PCB test kit). Samples of the oil collected in November 1977 indicate the fluid in the transformer had a PCB concentration of approximately 3 percent. In October 1985, the oil was reported to have a PCB concentration greater 500 ppm (test method unknown). In November 1986, wipe samples collected from a valve, sidewall, and the concrete pad were found to contain 29.8, 5.0, and 417.5 ppm PCBs, respectively. Also in November 1986, a wipe sample collected from the concrete pad beneath the drain valve was found to contain 498 micrograms per square centimeter ($\mu\text{g}/\text{cm}^2$) PCBs. Soil samples collected in November 1986 from the south edge of the original transformer pad indicated 14,900 ppm PCB contamination (DOE 1992).

In September 1976, Transformer 776-4 was documented as being drained and refilled with a non-PCB silicone oil. The transformer was scheduled for replacement under the PCB Fire Hazard Elimination Project in FY1988.

In March 1989, it was reported that transformer 776-4 was replaced under the Environmental Hazards Elimination Project. Further remediation of the site was scheduled on August 10, 1989 (DOE 1992).

PAC 700-1102 was recommended for NFA in 1997 based upon removal of the contaminant source. Comments received from the regulatory agencies on July 19, 1999 concluded that NFA of this PAC would be granted if downgradient groundwater samples were collected verifying that PCB contamination is not mobilized in the subsurface which could affect surface water.
